**TRAFFIC OPERATIONS ASSESSMENT
MALDEN CENTRAL BUSINESS DISTRICT
MALDEN, MASSACHUSETTS**

TRAFFIC OPERATIONS ASSESSMENT
MALDEN CENTRAL BUSINESS DISTRICT

FINAL REPORT

Prepared by: BETA Group, Inc.

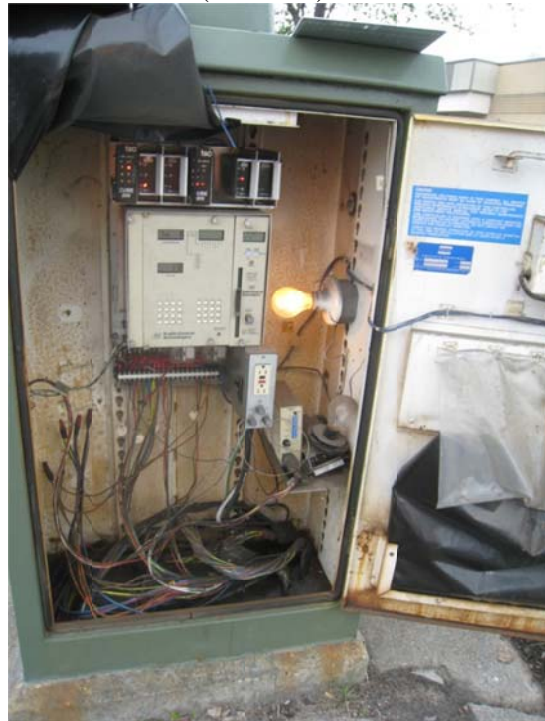
7. Centre Street (Route 60) at Jackson Street

This signal cabinet has been hit at some point causing the front door to be misaligned. The misalignment allows water to infiltrate into the cabinet. A plastic tarp has been draped inside the cabinet to protect the electrical equipment. The cabinet should be repaired or replaced. Replacement of the cabinet may also require full replacement of all the existing equipment within the current cabinet because of the age of the existing equipment.

- Replace the existing cabinet to solve water infiltration issues.
- **15. Centre Street (Route 60) at Main Street/10. Exchange Street at Main Street:**
